RE: Milliken and Company – Hillside Plant
LaGrange, Troup County, Georgia
Site Inspection Report

SITE INSPECTION

**MILLIKEN & COMPANY – HILLSIDE PLANT
LAGRANGE, TROUP COUNTY, GEORGIA
GAD 981 275 993**

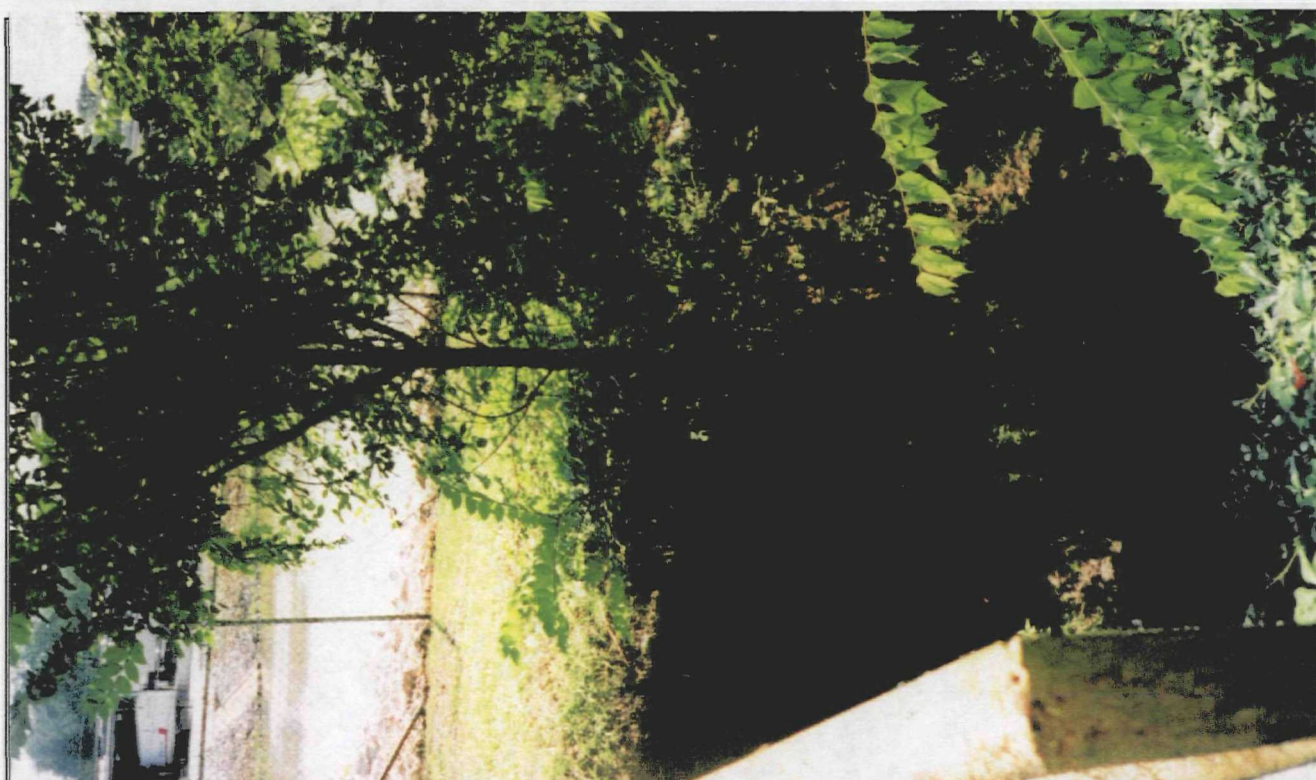
Site: Milliken – Hillside Mill	County: Troup	City: LaGrange	Photo: 2 of 8
Photographer: Andrew Taft	Date: July 19, 2007	Time: 10:42 AM	Direction Facing: E
Explanation: The depicted small stream (originating just north of the site) flows in a southeastern direction near the western boundary of the site. The depicted culvert is located near the northwest corner of the on-site fire pond (note fire pond in background).

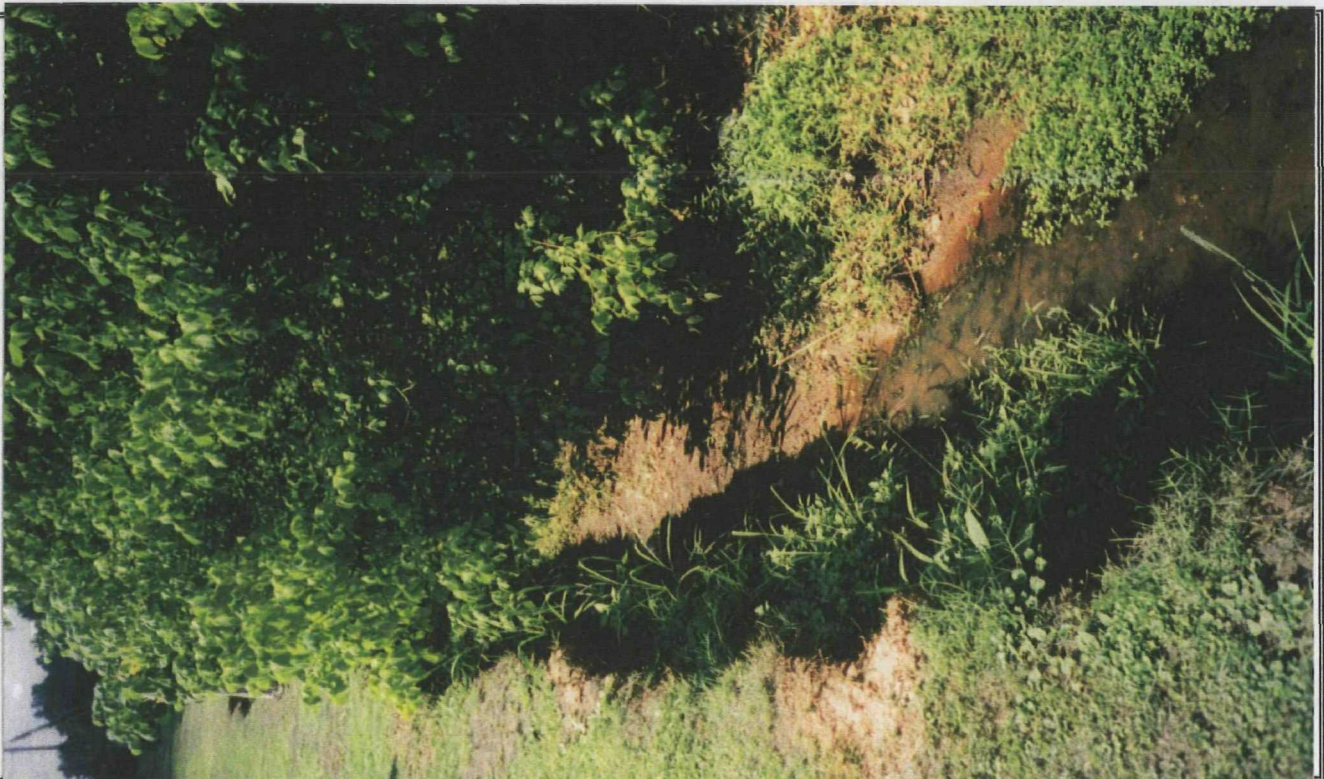
Site: Milliken – Hillside Mill	County: Troup	City: LaGrange	Photo: 3 of 8
Photographer: Andrew Taft	Date: July 19, 2007	Time: 10:45 AM	Direction Facing: SE
Explanation: The small stream, flowing southeast near the western boundary of the site, separates the site from adjacent private residences to the west. At the time of the reconnaissance, the stream exhibited a low flow volume. Mr. Bethea stated that approximately nine (9) years ago, the stream consisted of just a few intermittent puddles.

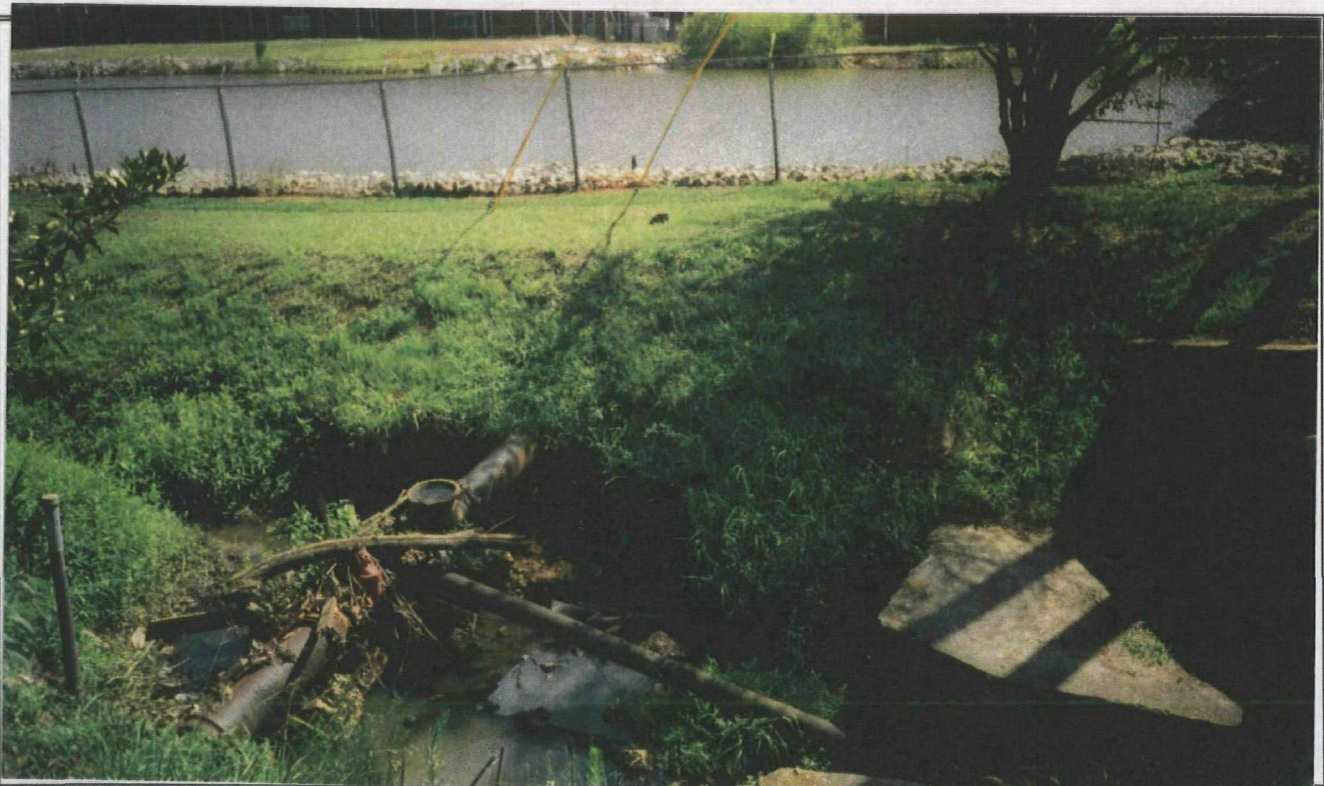
Site: Milliken – Hillside Mill	County: Troup	City: LaGrange	Photo: 4 of 8
Photographer: Andrew Taft	Date: July 19, 2007	Time: 10:53 AM	Direction Facing: NE
Explanation: The small stream, flowing southeast near the western boundary of the site, exits at the southwest corner of the site at the depicted culvert underlying Forth Avenue. During heavy rainfall, the fire pond drains to the stream via the depicted outfall pipe (note fire pond in background).

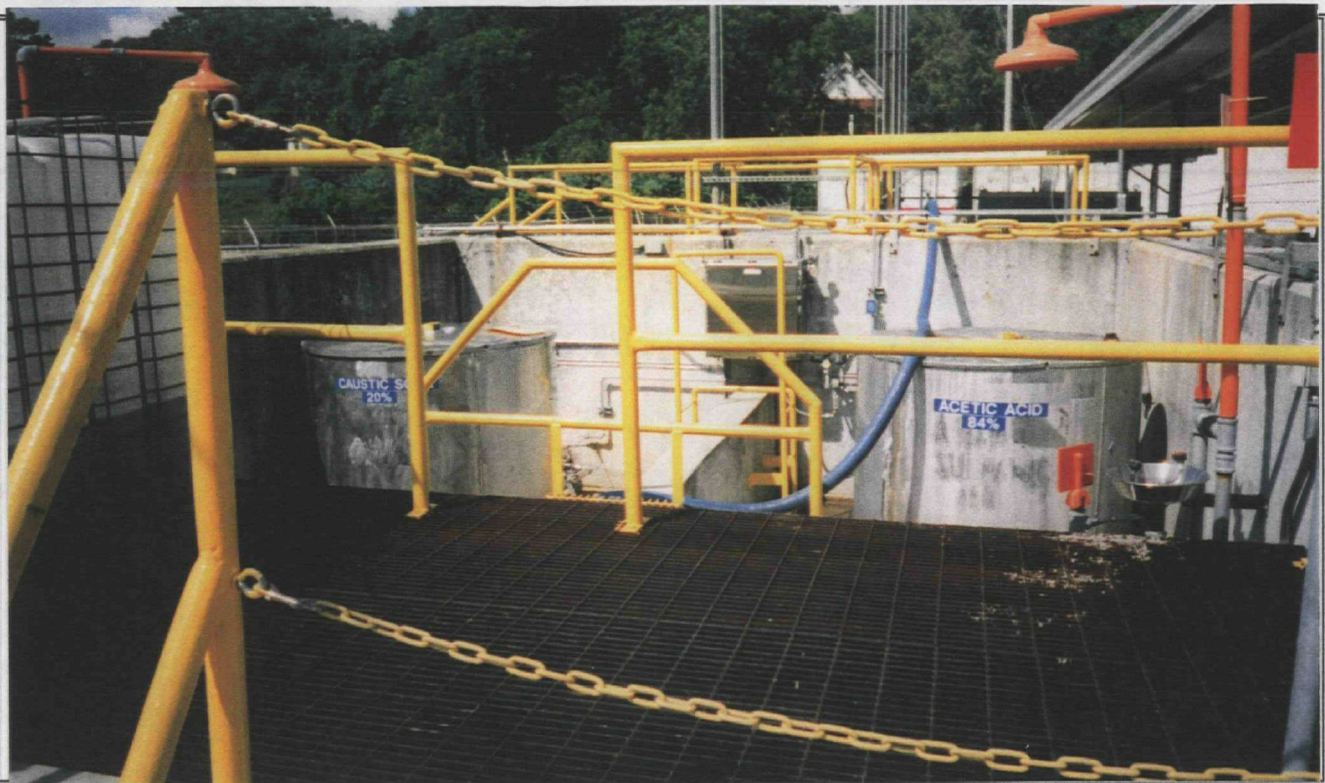
Site: Milliken – Hillside Mill	County: Troup	City: LaGrange	Photo: 5 of 8
Photographer: Andrew Taft	Date: July 19, 2007	Time: 11:09 AM	Direction Facing: SW

Explanation: Prior to discharge to the city sewer system, wastewater generated from on-site processes is pH adjusted within the depicted 16,807-gallon concrete neutralization basin. Note the two (2) 250-gallon tanks containing caustic soda and acetic acid reagents for pH adjustment.

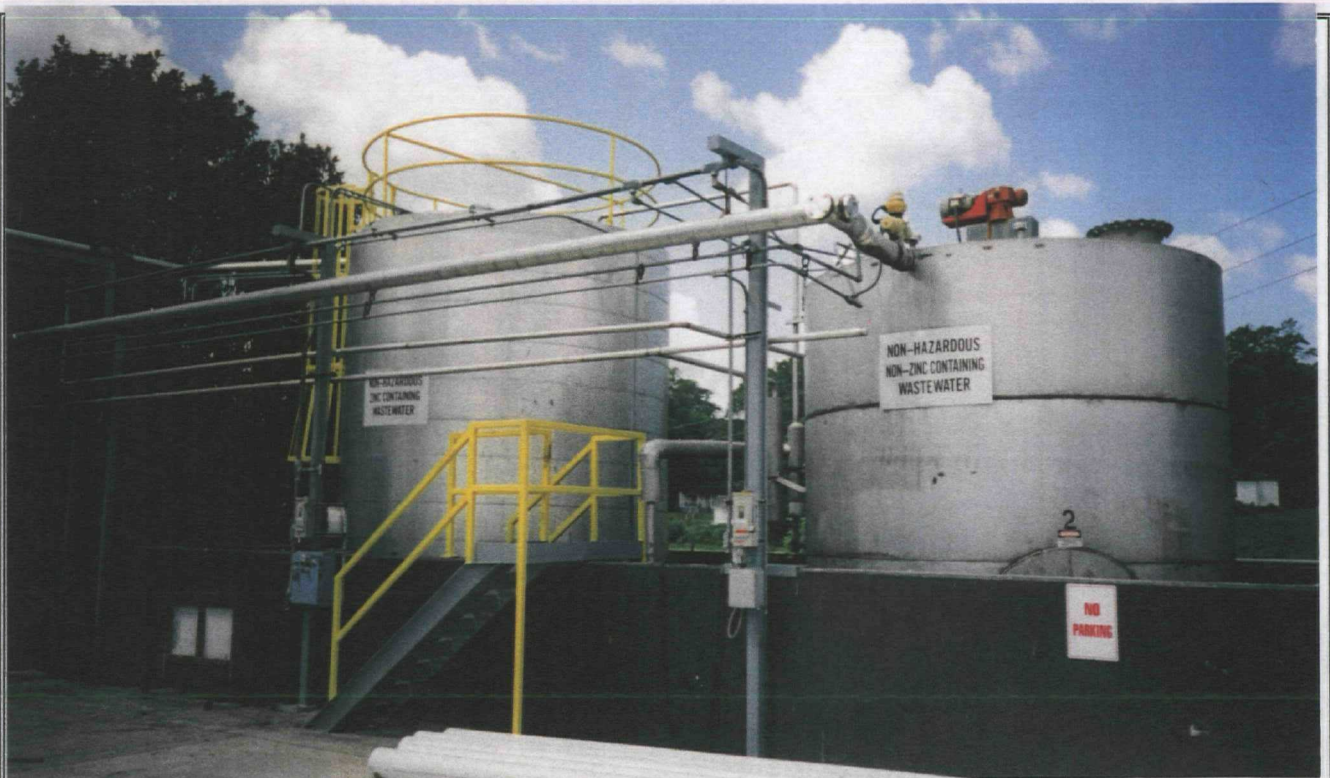
Site: Milliken – Hillside Mill	County: Troup	City: LaGrange	Photo: 6 of 8
Photographer: Andrew Taft	Date: July 19, 2007	Time: 11:43 AM	Direction Facing: SW

Explanation: The depicted two (2) 12,000 gallon tanks are used to contain wastewater generated from on-site processes prior to pH adjustment within the neutralization basin. Mr. Moe stated that under certain circumstances, it is necessary to “drum-up” wastewater within the tanks for off-site disposal rather than discharge to the city sewer system.

10. At the time of the reconnaissance, two (2) tanks comprising a tank farm were observed in the general vicinity of the neutralization basin (see Attachment A: Photo 6 of 8). Mr. Moe confirmed that the tanks were used to contain wastewater generated from on-site processes prior to pH adjustment within the neutralization basin. Mr. Moe indicated that wastewater within the tanks can contain zinc, formaldehyde, ammonia and latex waste, and that under certain circumstances, it is necessary to "drum-up" wastewater within the tanks for off-site disposal rather than discharge to the city sewer system. Mr. Bennett later confirmed that the capacity of each of the tanks was 12,000 gallons, for a total of 24,000 gallons (see Attachment C: July 27, 2007 Memo from Bennett Regarding Tank Volumes).

Two (2) twelve thousand (12,000) gallon metal aboveground storage tanks are located in the general vicinity of the above described neutralization basin (Refs. 5 & 18), (see Appendix B, Attachment A: Photo 6 of 8 of the PA Report). The tanks are used to contain wastewater generated from on-site processes prior to pH adjustment within the neutralization basin (Ref. 5). Wastewater within the tanks can contain Zinc, Formaldehyde, Ammonia and Latex Waste, and under certain circumstances it is necessary to containerize the wastewater in drums for off-site disposal rather than discharge to the city sewer system.

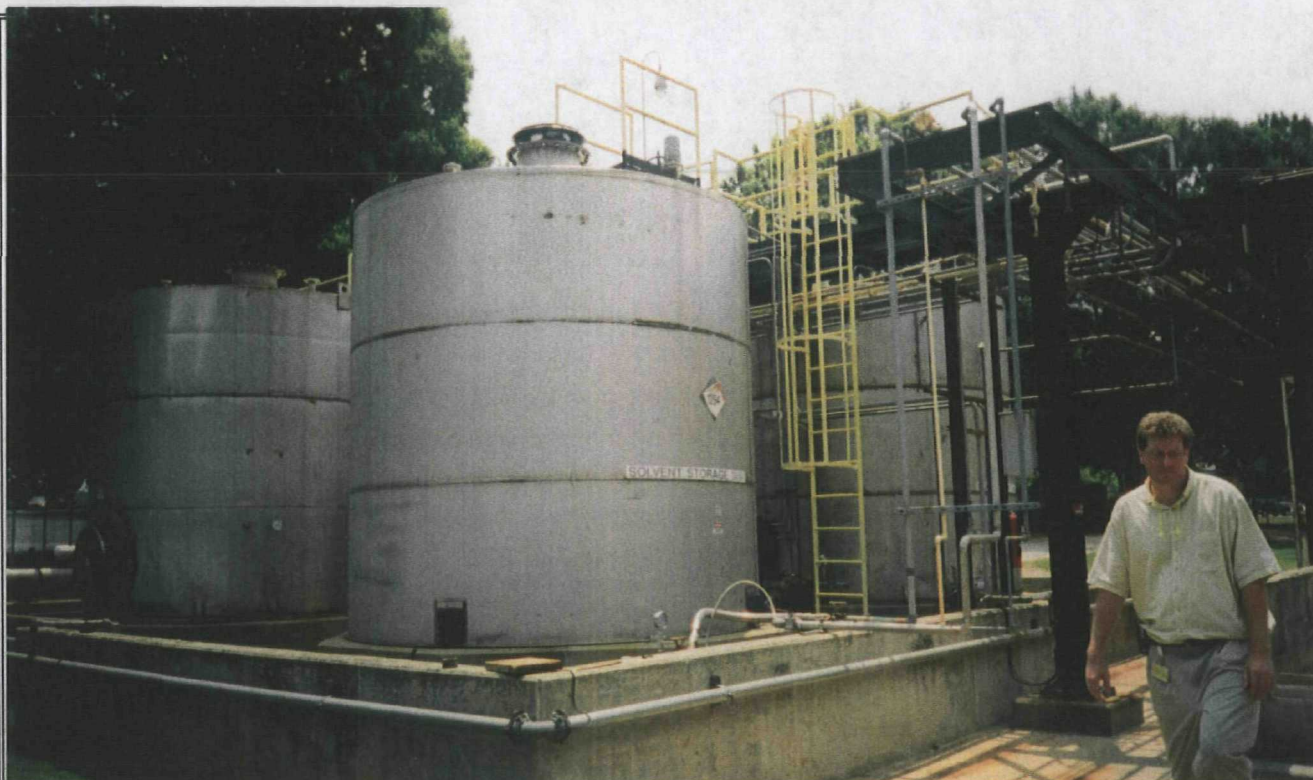
Site: Milliken – Hillside Mill	County: Troup	City: LaGrange	Photo: 7 of 8
Photographer: Andrew Taft	Date: July 19, 2007	Time: 12:45 PM	Direction Facing: SE

Explanation: At the northeast corner of the site, toluene is stored in one (1) of four (4) 10,000-gallon tanks. At the time of the reconnaissance, Mr. Moe stated that the other three (3) tanks were empty. Toluene product is used to dissolve silicon in the on-site manufacturing of automobile safety air bags.

19. According to Mr. Moe, toluene is stored in one (1) of four (4) above ground storage tanks comprising a tank farm located at the northeast corner of the site (see Attachment A: Photo 7 of 8). At the time of the reconnaissance, Mr. Moe stated that the other three (3) tanks were empty. Mr. Moe estimated that the capacity of each tank to be 10,000 gallons (for a total of 40,000 gallons). Mr. Bennett later confirmed that estimate to be accurate (see Attachment C: July 27, 2007 Memo from Bennett Regarding Tank Volumes).

Four (4) ten thousand (10,000) gallon metal aboveground storage tanks comprising a tank farm are located near the site's northeast corner (Refs. 5 & 18), (see Appendix B, Attachment A: Photo 7 of 8 of the PA Report). At the time of the July 2007 site reconnaissance, a site representative indicated that Toluene was stored in one (1) tank with the remaining three (3) tanks being empty (Ref. 5).

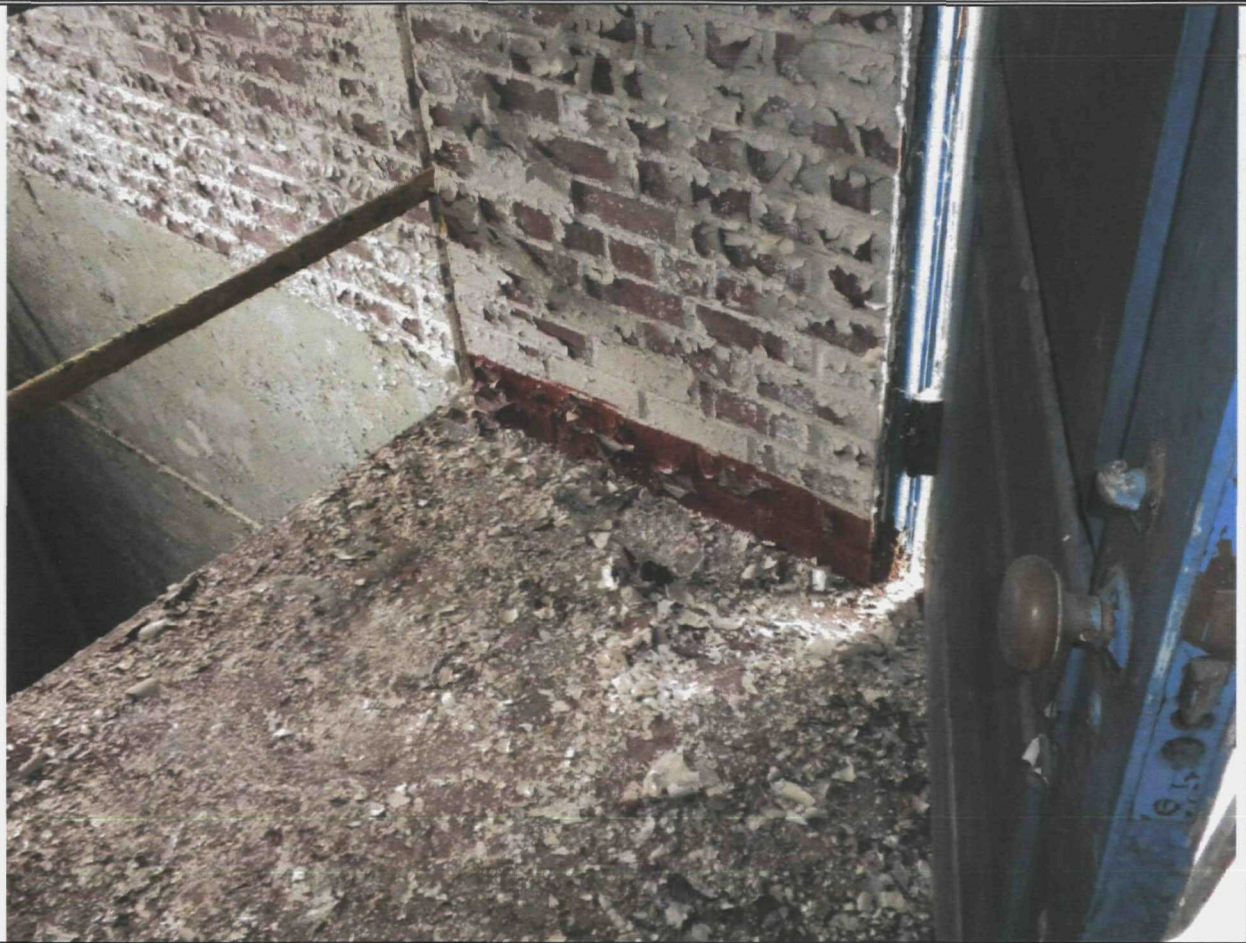
Depiction of waste paint chips collected from on-site Sample Station No. STA-16-WS (HW10998).

- STA-16-WS (HW10998) – Waste solid sample (paint chips) collected on-site, from within multistory vacant brick building (old water treatment plant), to determine whether hazardous substances attributable to the site are present at this location (see Appendix D, Attachment D: Photos 1 & 2 of 53); and

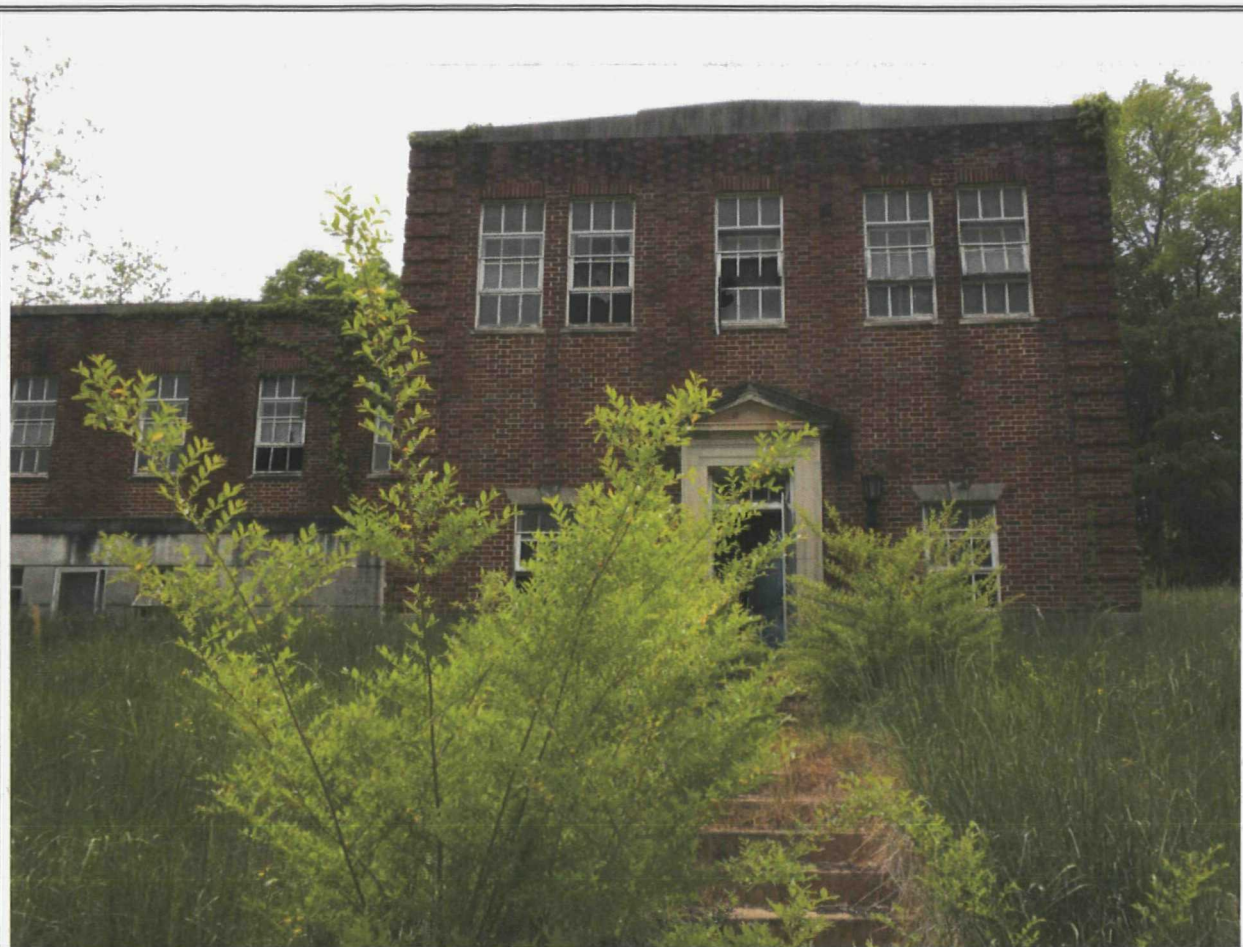
On-site Sample Station No. STA-16-WS (HW10998) is located within the depicted multi-story brick building (behind open blue door).

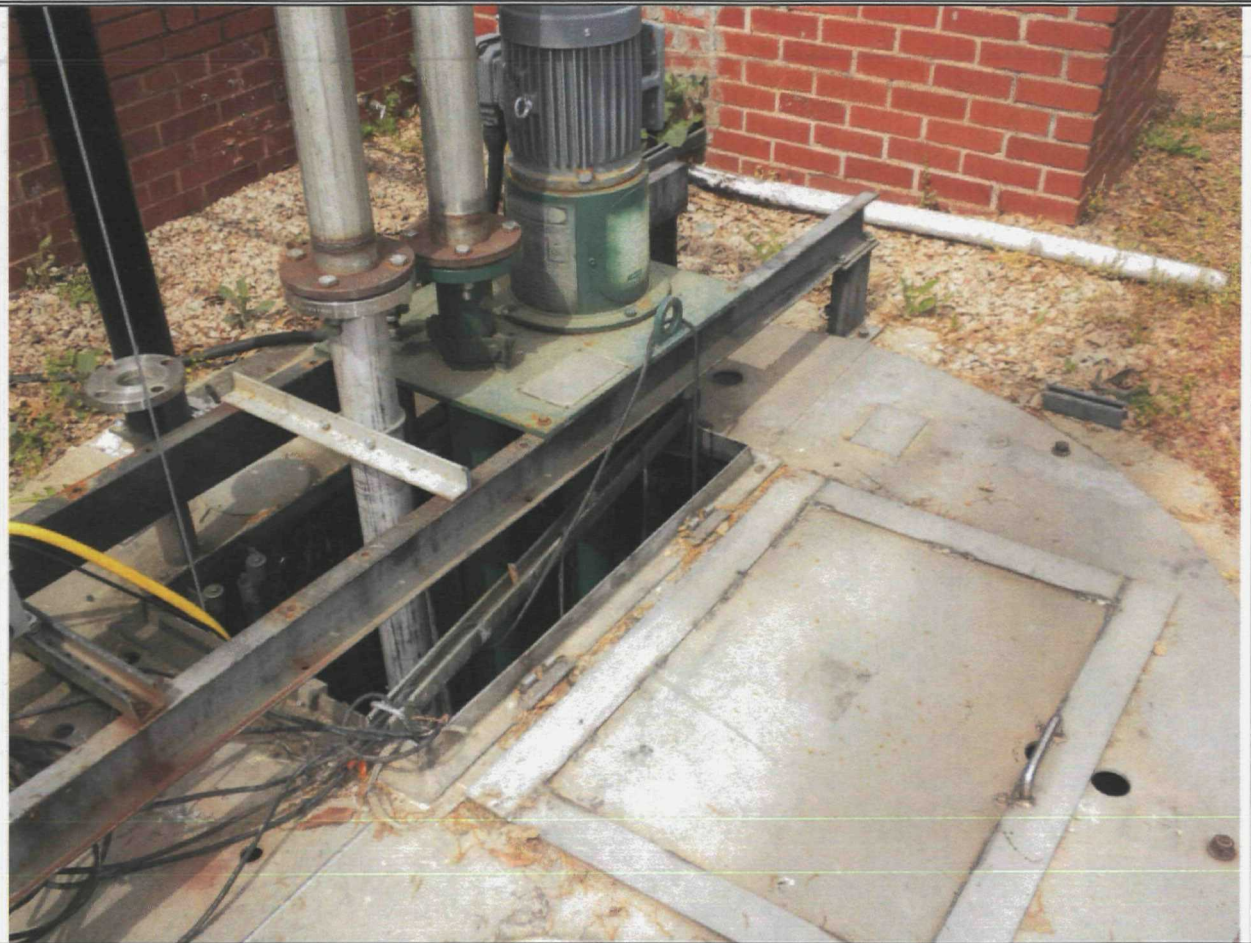
Depiction of sump near Forth Avenue where waste water was collected from on-site Sample Station No. STA-28-WL (HW11014).

- STA-28-WL (HW11014) – Waste liquid sample collected on-site, from sump near Forth Avenue, to determine whether hazardous substances attributable to the site are present at this location (see Appendix D, Attachment D: Photos 3 & 4 of 53).

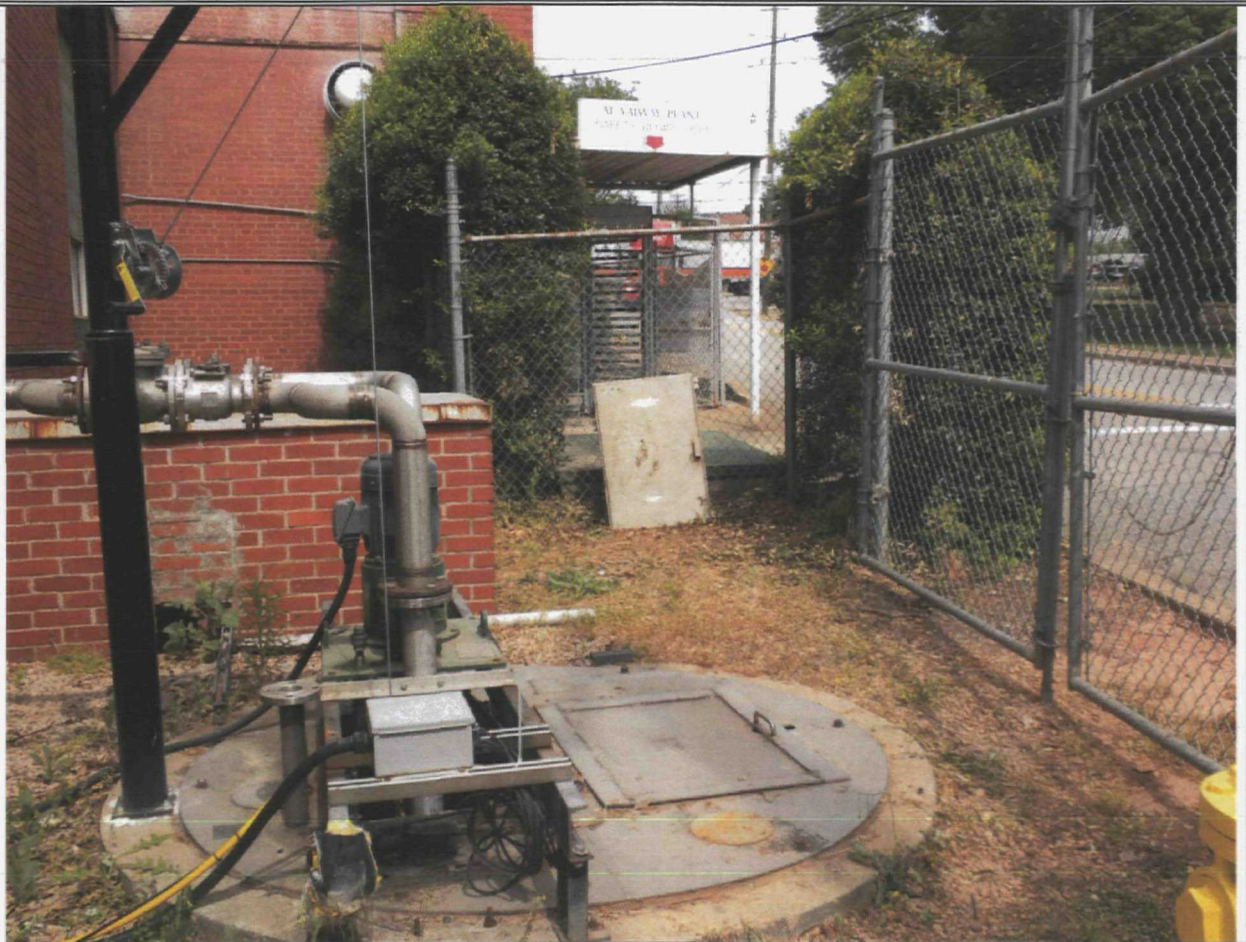
Depiction of sump near Forth Avenue where waste water was collected from on-site Sample Station No. STA-28-WL (HW11014).

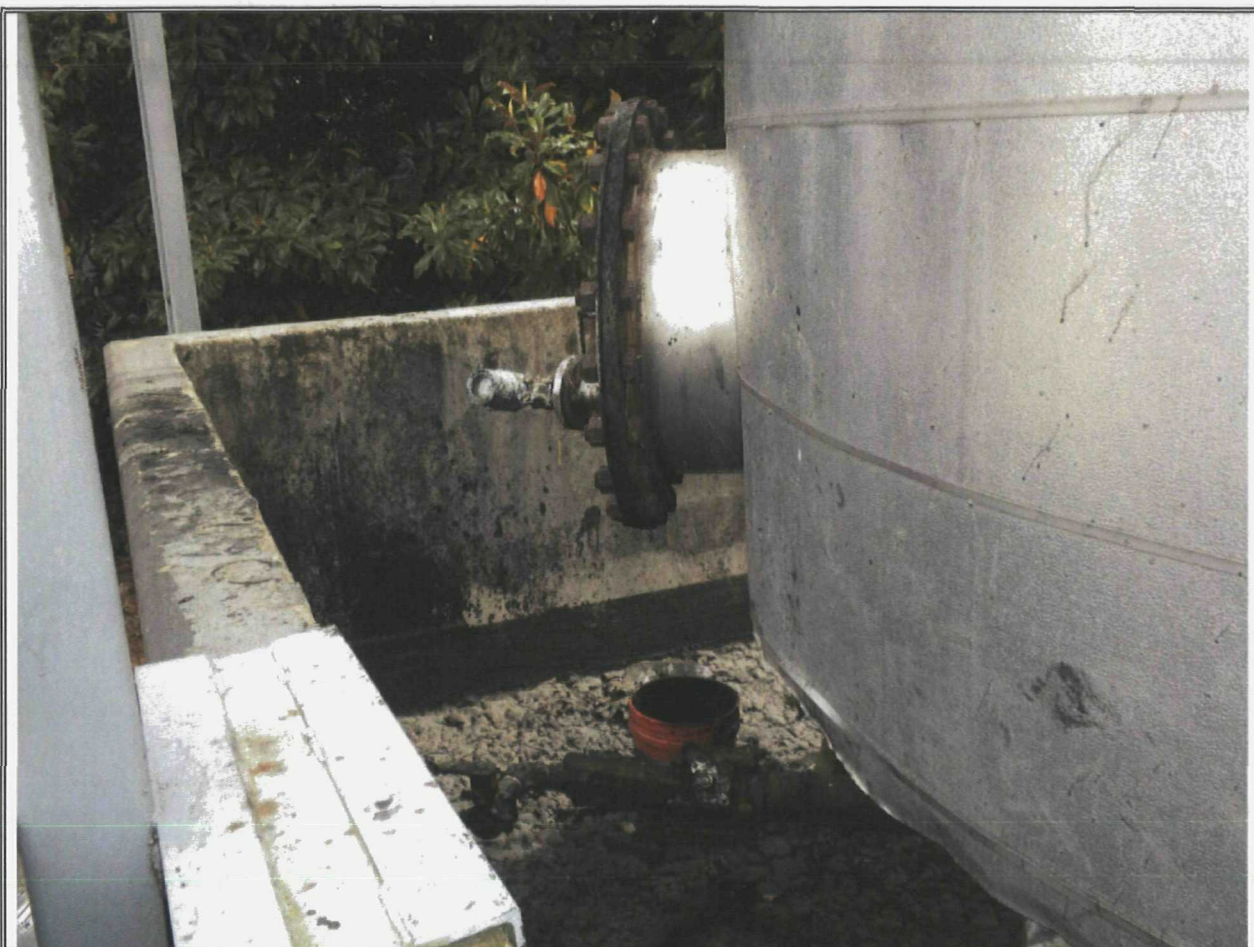
Depiction of tank valve where waste water was collected from on-site Sample Station No. STA-15-WL (HW10997).

- STA-15-WL (HW10997) – Waste liquid sample collected on-site, from twelve thousand (12,000) gallon above ground tank, to determine whether hazardous substances attributable to the site are present at this location (see Appendix D, Attachment D: Photos 5 & 6 of 53);

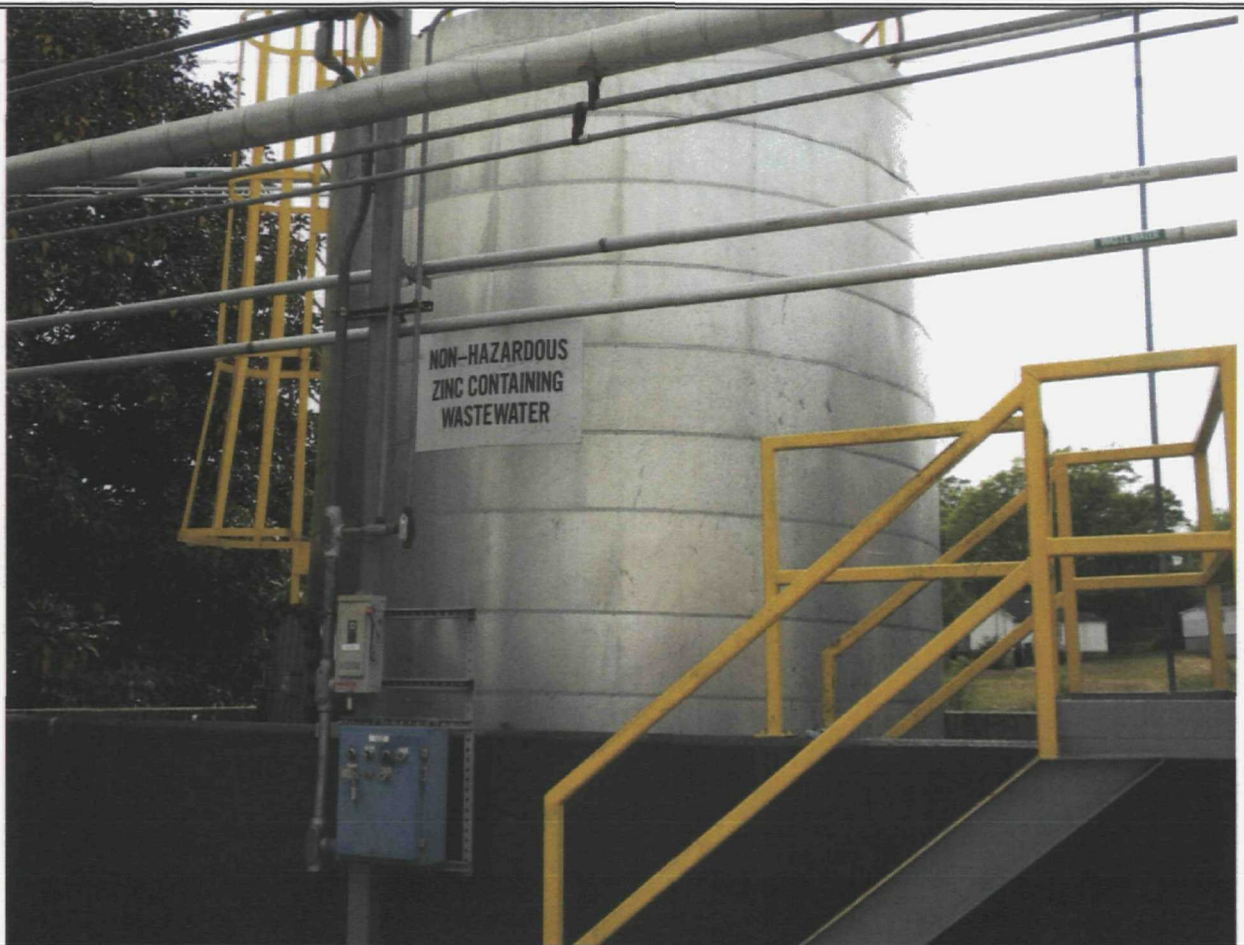
Depiction of one (1) of two (2) 12,000 gallon above ground storage tanks where waste water was collected from on-site Sample Station No. STA-15-WL (HW10997).

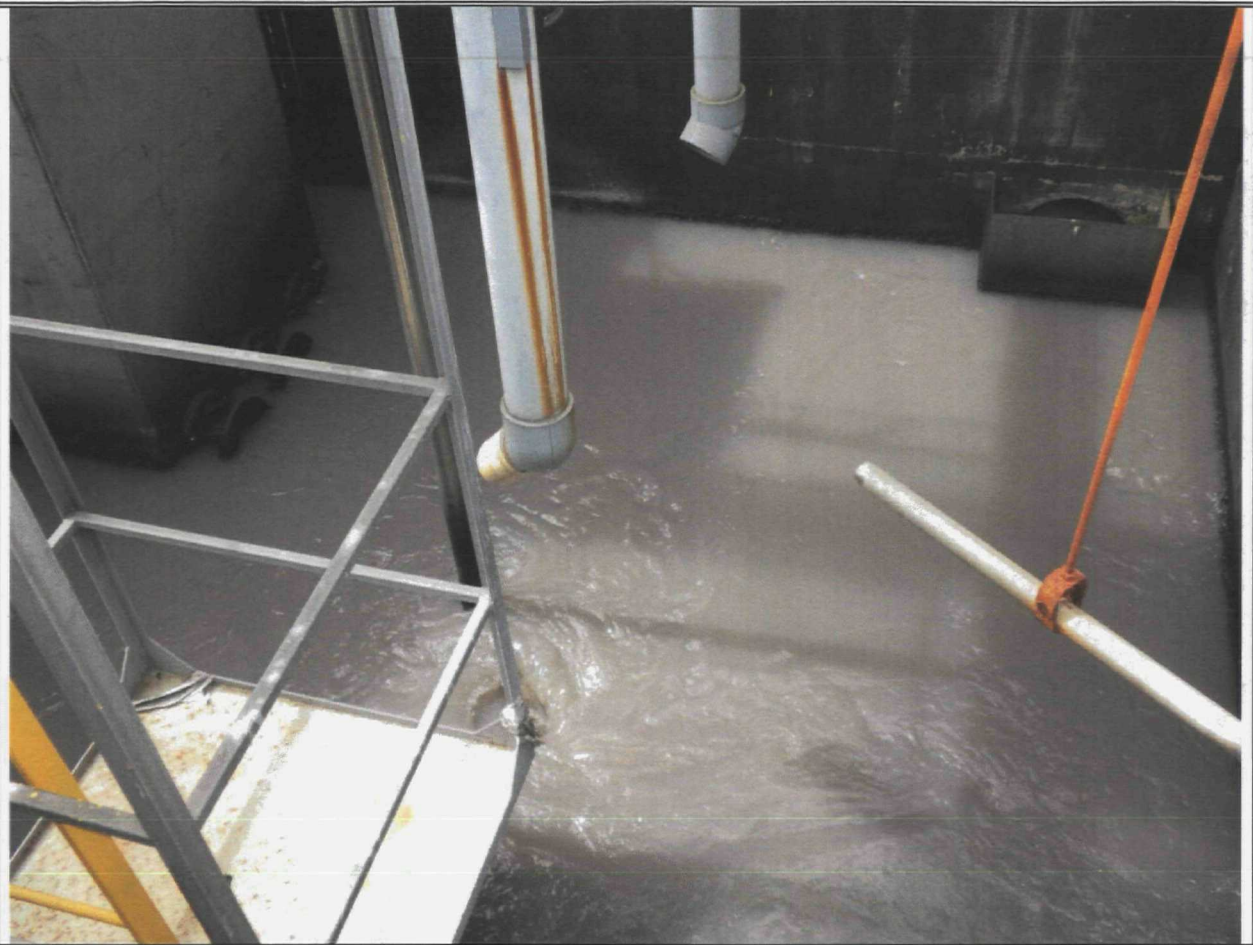
Depiction of concrete neutralization basin where waste water was collected from on-site Sample Station No. STA-14-WL (HW10996).

- STA-14-WL (HW10996) – Waste liquid sample collected on-site, from concrete neutralization basin, to determine whether hazardous substances attributable to the site are present at this location (see Appendix D, Attachment D: Photos 7 & 8 of 53);

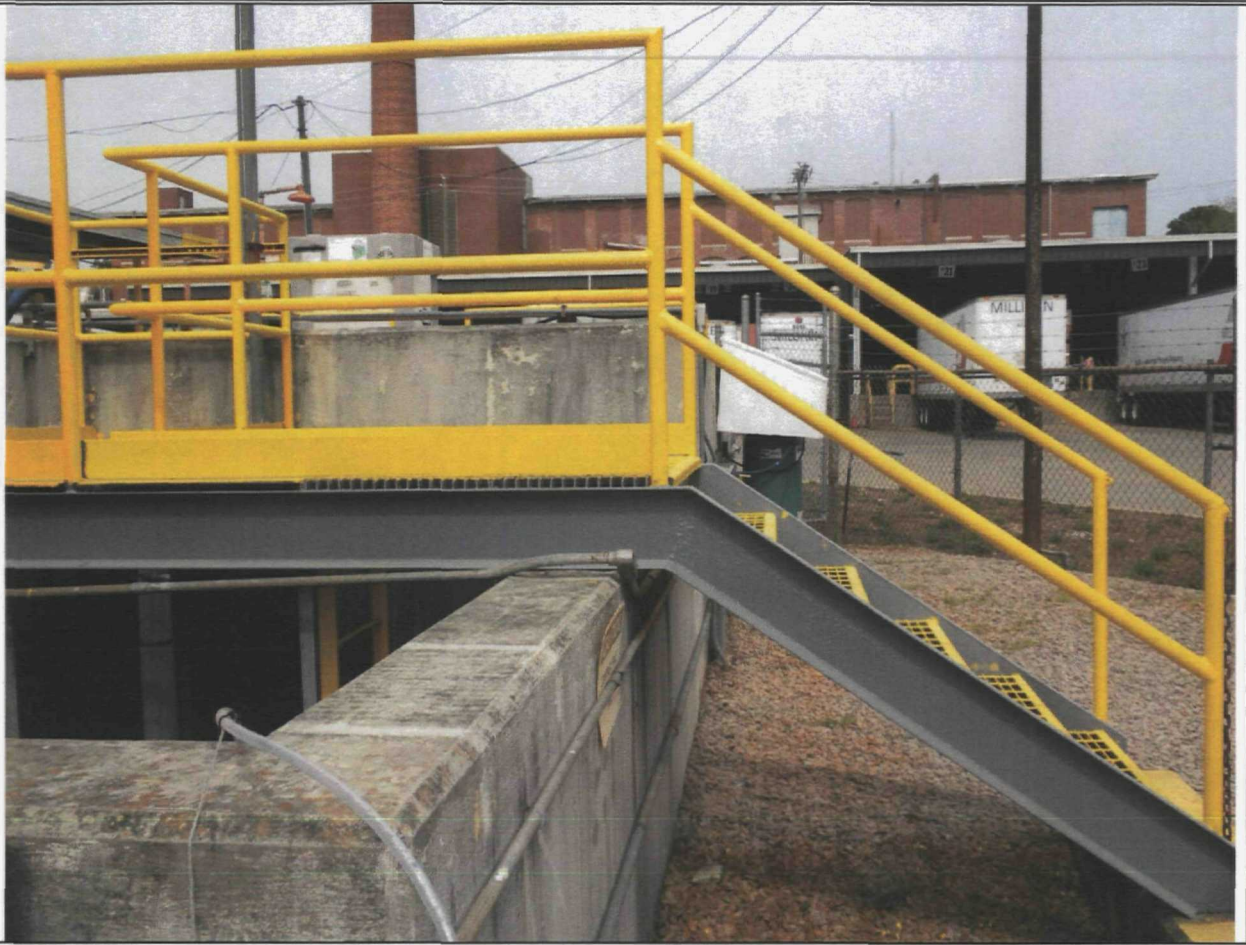
Depiction of concrete neutralization basin where waste water was collected from on-site Sample Station No. STA-14-WL (HW10996).

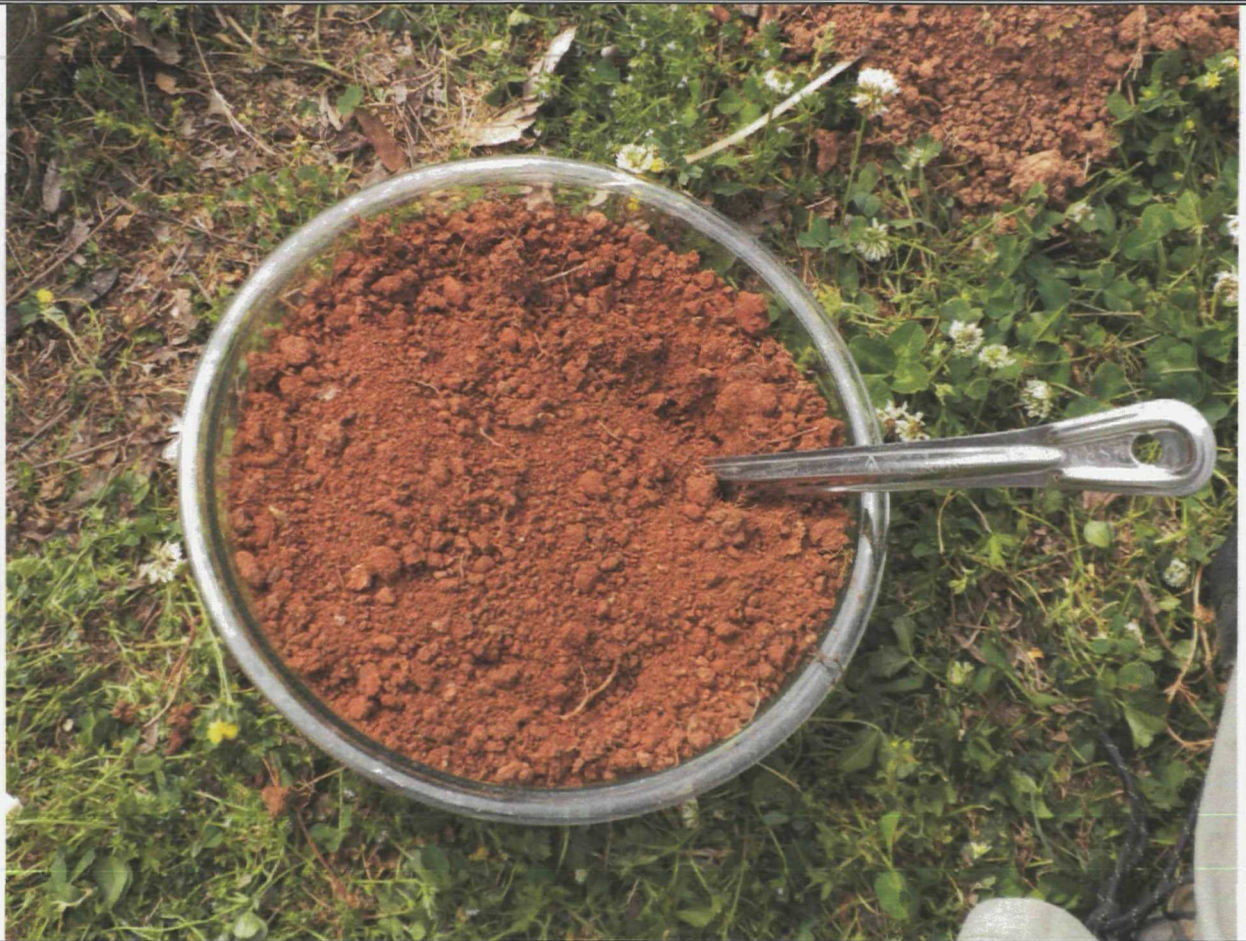
Depiction of surficial soil sample matrix collected from on-site Sample Station No. STA-19-SS (HW11002).

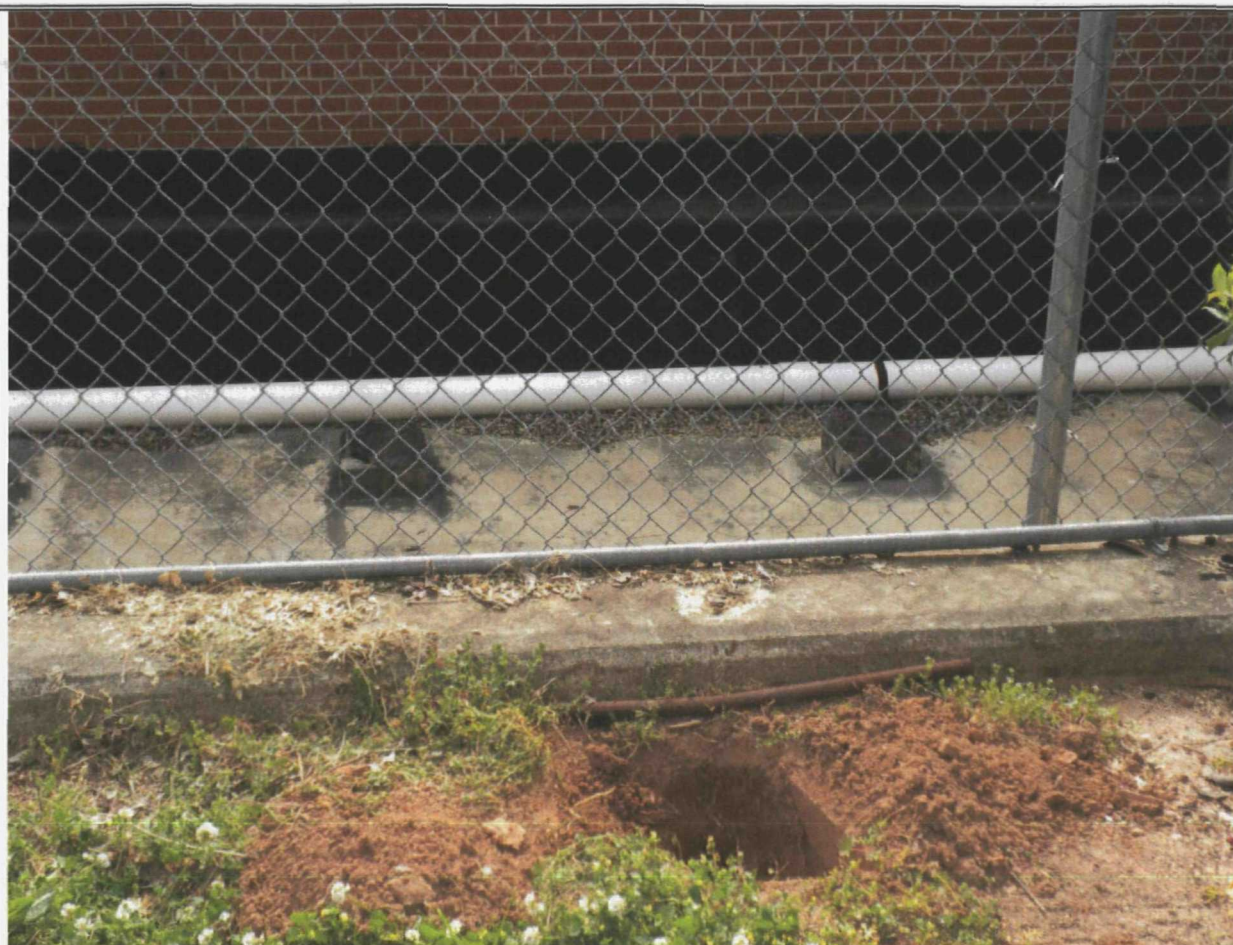
Depiction of immediate vicinity of on-site Sample Station No. STA-19-SS (HW11002).

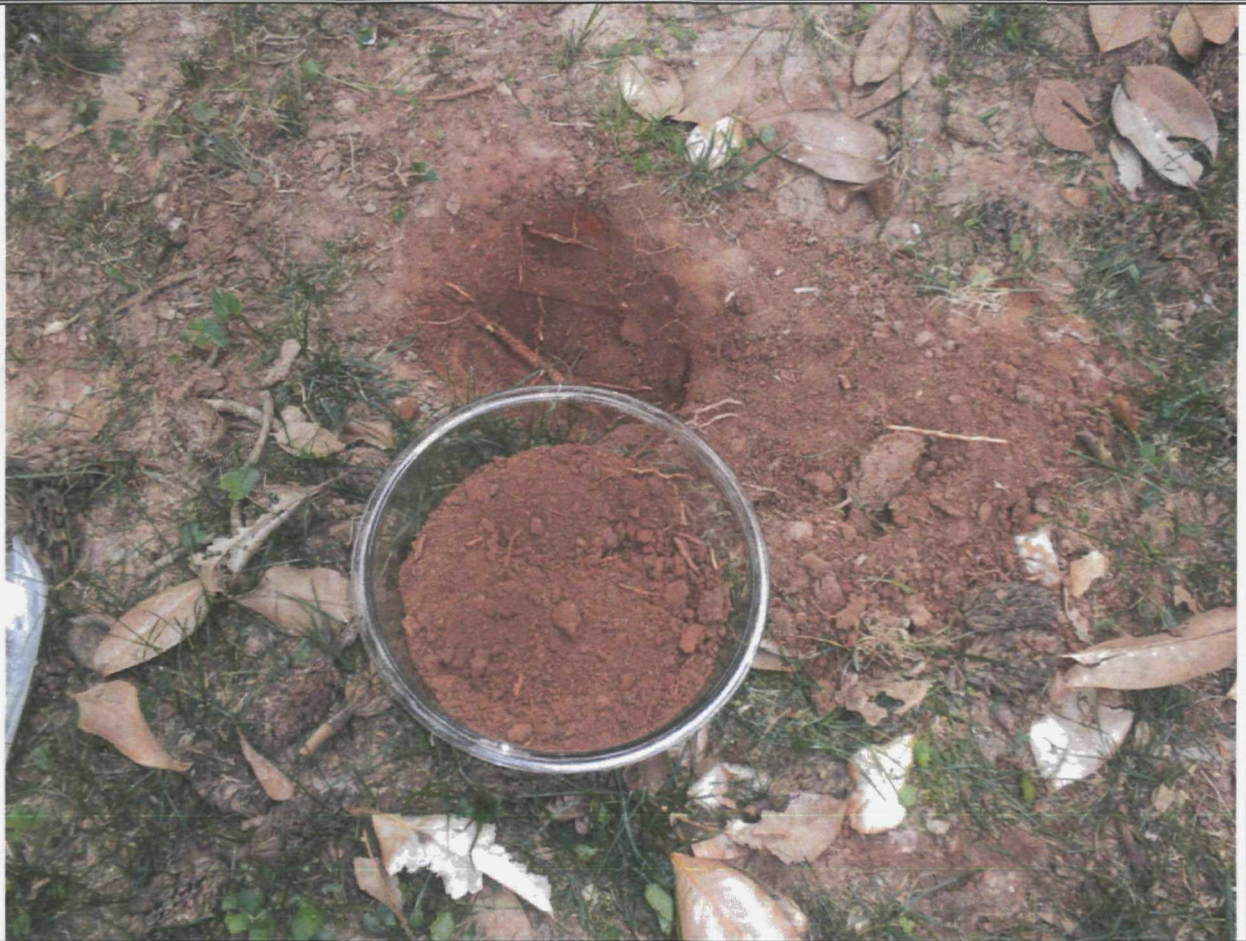
Depiction of surficial soil sample matrix collected from on-site Sample Station No. STA-20-SS (HW11003).

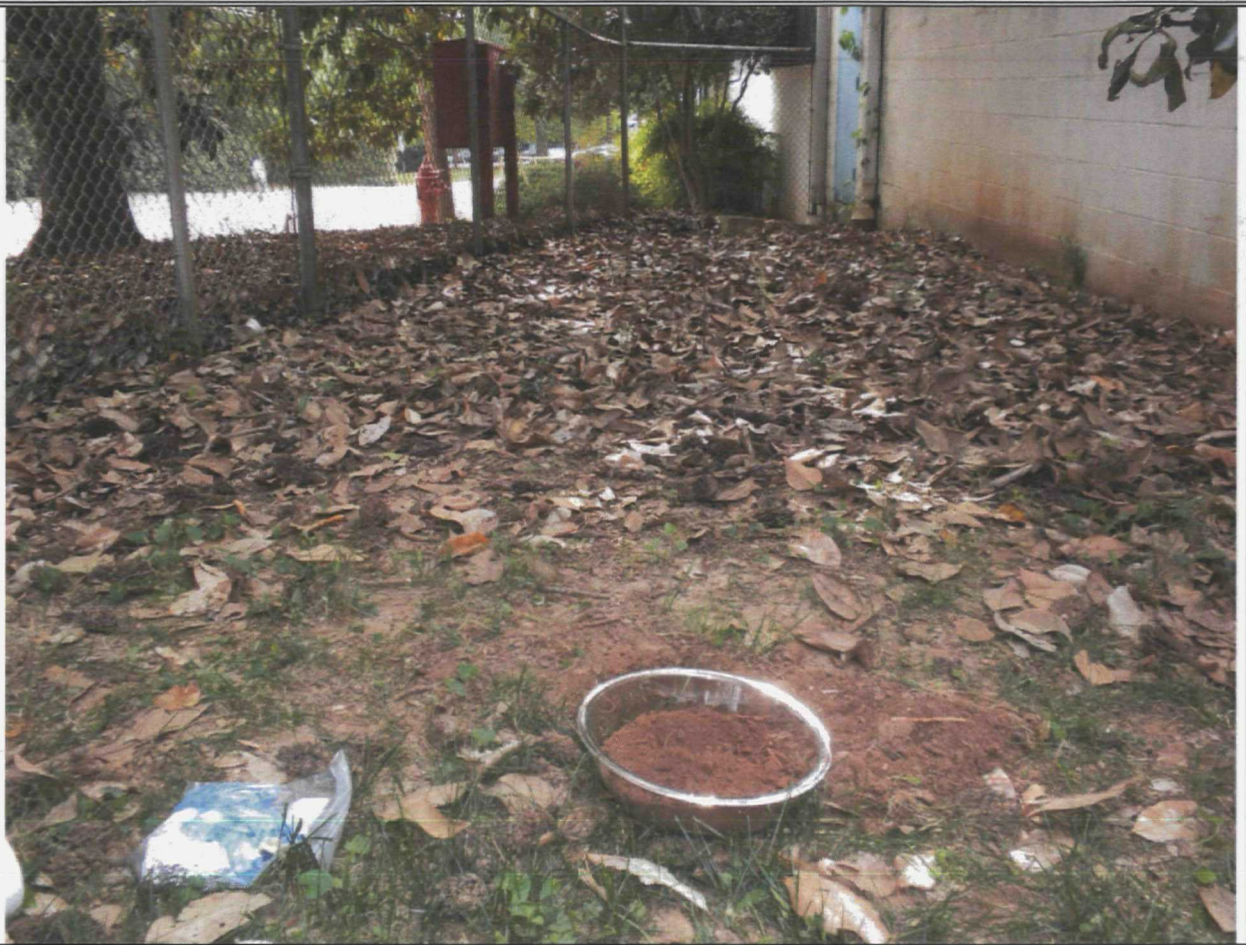
Depiction of immediate vicinity of on-site Sample Station No. STA-20-SS (HW11003). Note Fourth Avenue in background.
